WATER DAM LEAKAGE INSPECTION

ERT geophysical inspection to find potential seepage areas in an earthen dam

CASE HISTORY

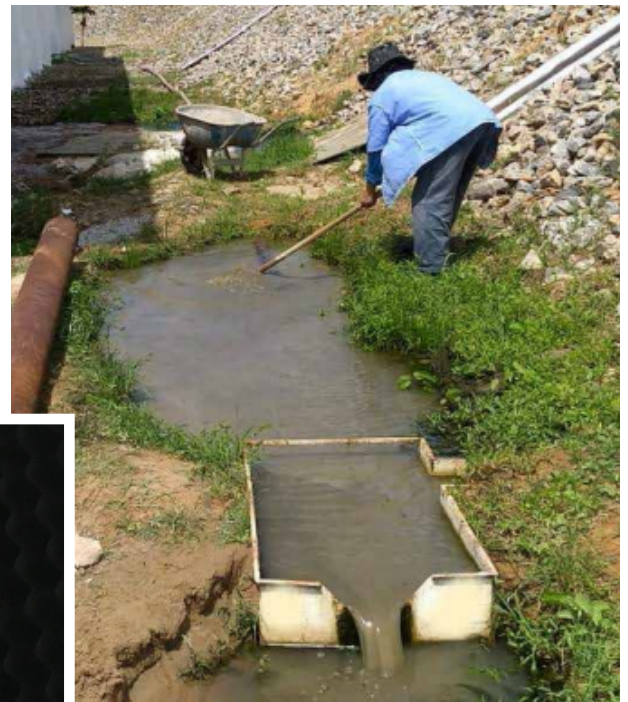
When visible pools of water were seen on the surface near the dam, it was obvious that a leak had occurred. The leak produced water at roughly 10L/s. It was unknown if this seepage was coming from the dam's levee structure or in the subsurface below. An Electrical Resistivity Imaging (ERI) profile was needed to map areas as potential sources of this leakage.

Pictured above: Visible surface leakage from the dam.

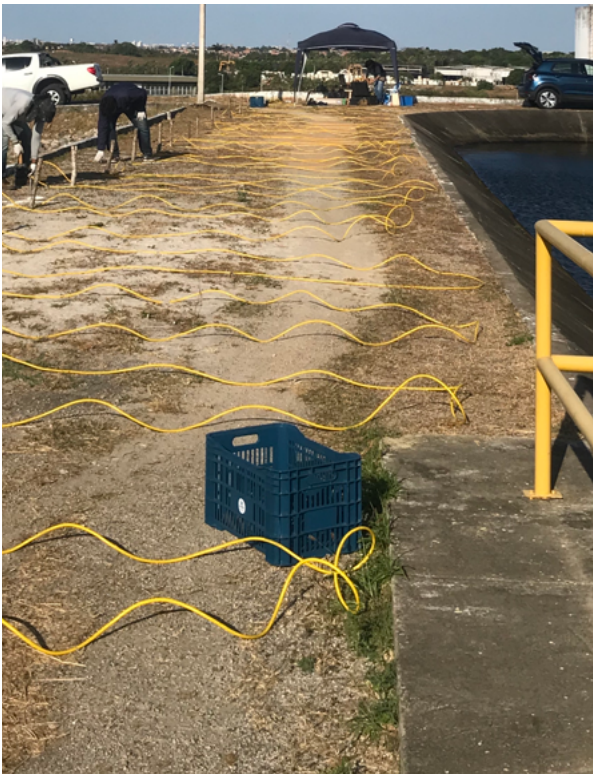
Pictured below: Installation of the line of electrodes that connect to the SuperSting RES/IP/Sp system.

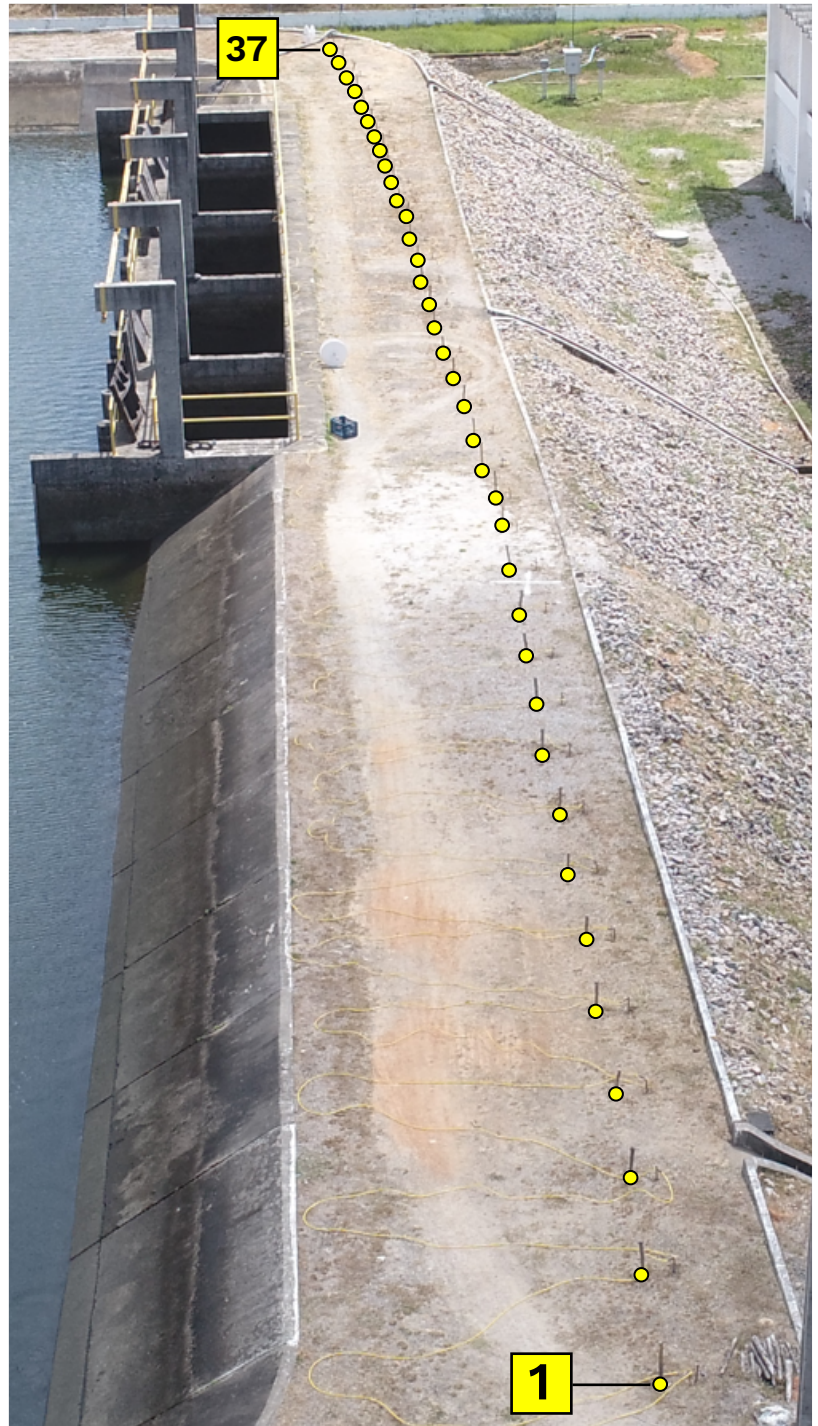
Pictured above: The placement of the 37 electrodes installed on the dam's crest. The space between each electrode was 2m.

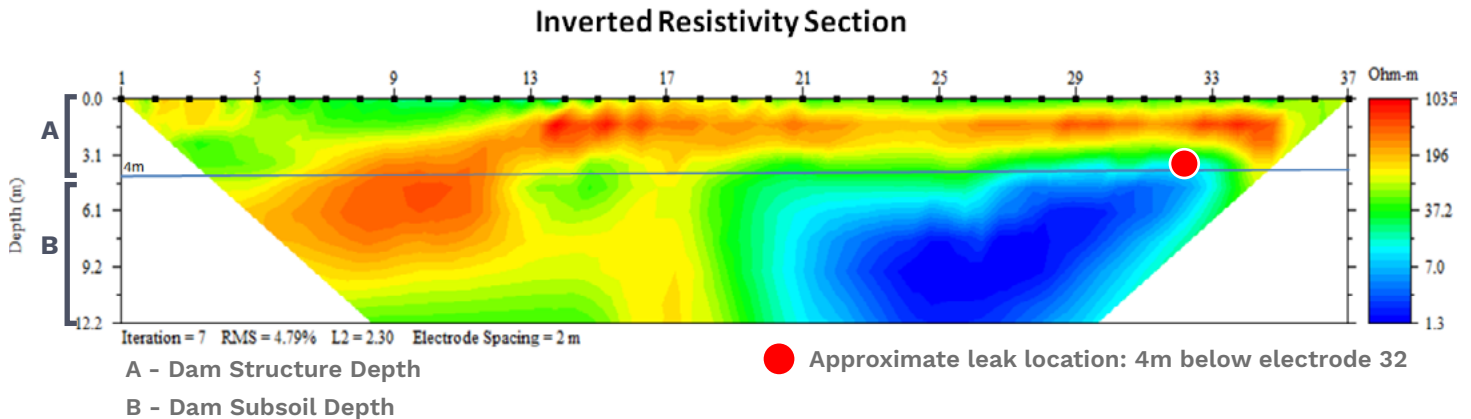
Preliminarily, it was believed that the leak originated somewhere in the dam structure (A) since the leak was visible on the surface.

After an analysis of the 2D resistivity model, integrated with topographic data, the dam's primary conductive anomaly was found in the subsoil beneath the dam structure (B). The conductive anomaly is depicted via the blue areas between electrodes 20 through 33 in the inversion model above.

A 5-pipe sluice structure was located on the same crest near the leak. These 900mm pipes had a depth of 7m and were associated with the conductive anomaly in the subsurface—which was near the eastern sector of the structure.

All data indicated to Global Image that the water accumulated in the subsoil and made its way to the surface. As the primary and starting point of the leak is close to electrode 32, the sector east of the pipeline structure could be committed.

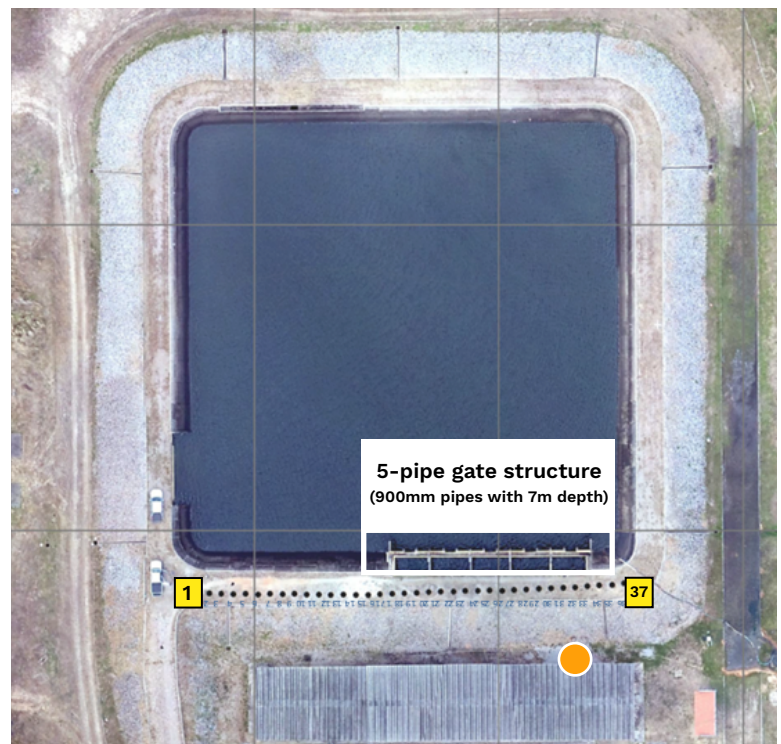
● The location where the leak was visible on the surface (10L/s)
