GEOTECHNICAL SITE INVESTIGATION

Assessing subsurface geological hazards for construction in Dubai

Objective: To assess the likely subsurface geologic hazards such as shallow/deep cavities, unconsolidated weak zones, and soft-soil formations that exist under the proposed construction site of a 1m diameter Gravity Sewer Line along King Salman Road, Dubai.

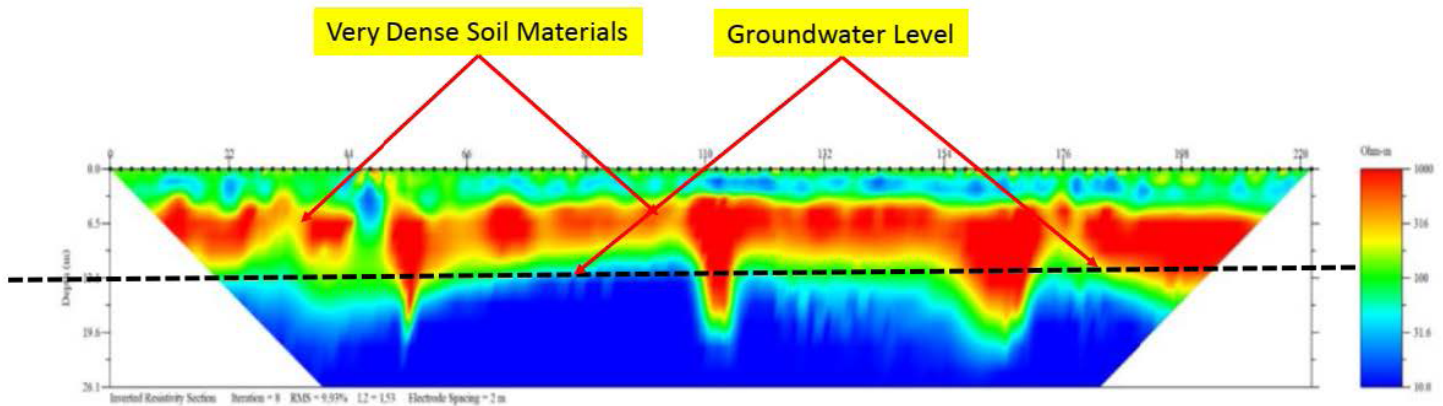
Figure 1: ERI Data detailing soil materials and groundwater levels

The ERI data above (Figure 1) shows the resistivity variation in the subsurface materials beneath the proposed construction site. It reflects a quite heterogeneous subsurface with large resistivity variations throughout the formation. The top layer is characterized with high resistivity values. Extremely low resistivity

numerical values have been observed below the black line on the chart. This is at a depth between 15.0m and 20.0m, below natural ground surface. The low resistivity was due to weak and water-saturated content in the weathered/ fractured soft bedrocks. This bedrock was rich with fragments of conductive materials.

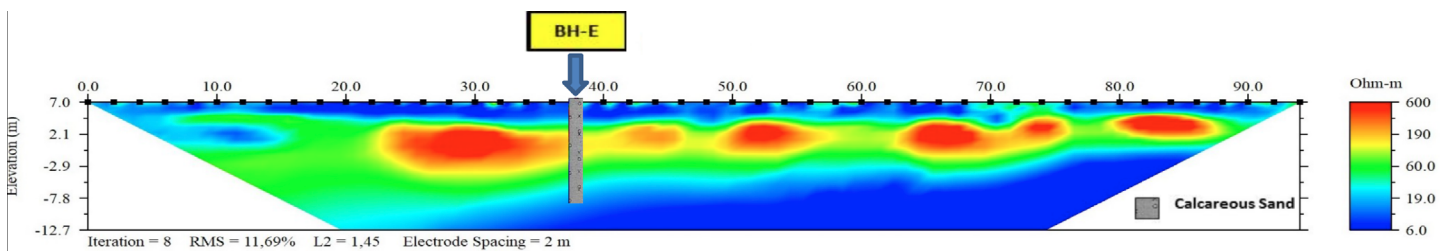
Figure 2: ERI Data inverted section with borehole

The inverted section above (Figure 2) showed a reasonable correlation between geotechnical results obtained from borehole BH-E and other resistivity values. Shallow blue colors are strong indications of saturated soil materials. The groundwater average level was traced from ERI images at shallow depths of about 7.0m from the natural ground surface.

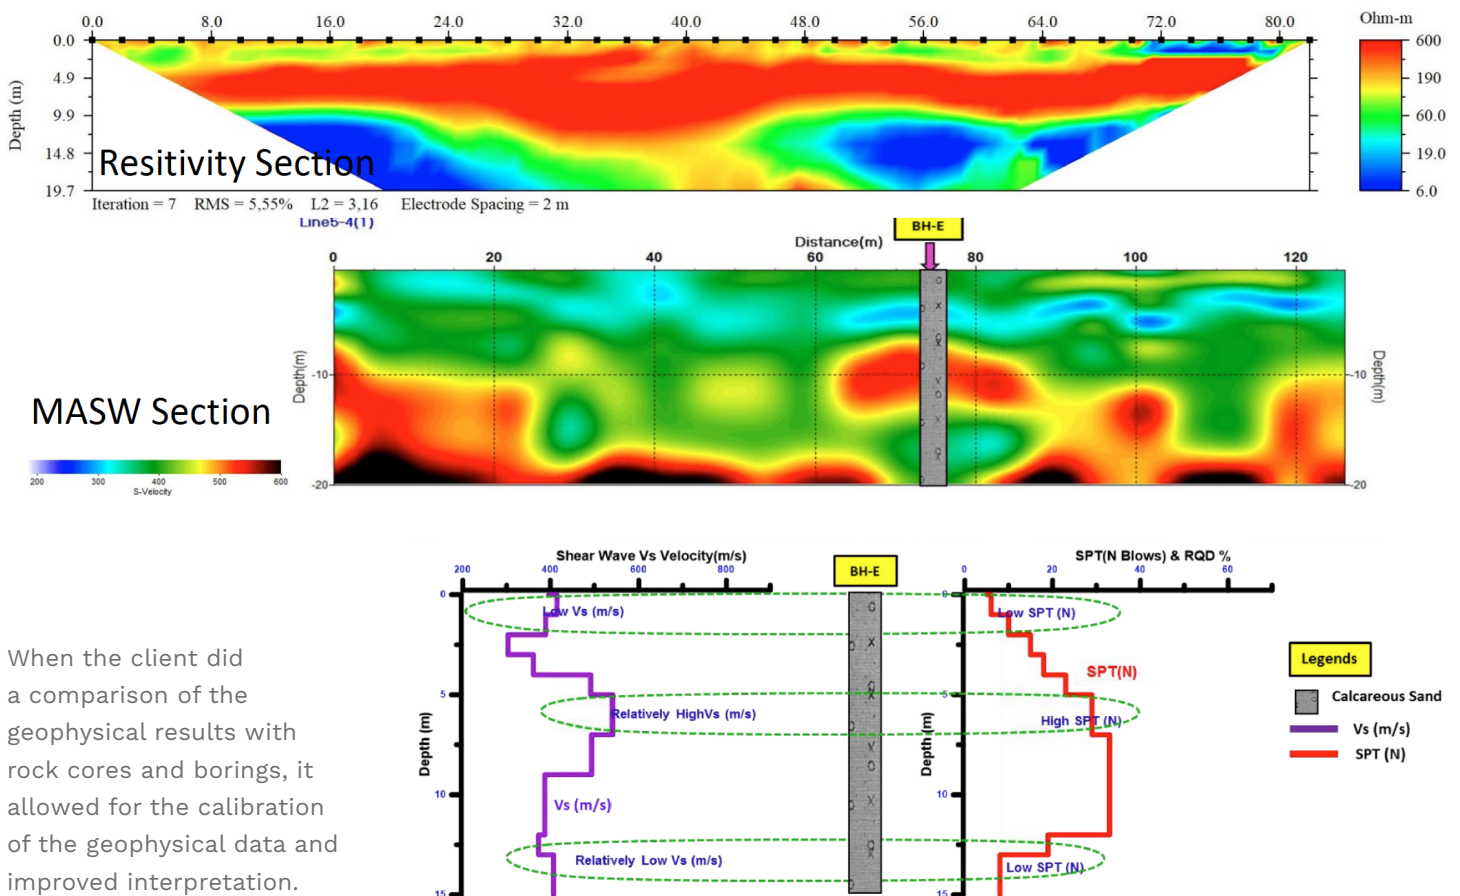
The extremely low resistivity values observed along all ERI lines confirmed the presence of highly-saturated and dense soil materials. The ERI profile also assisted in the approximating the spatial variability amongst all of the geohazards crossing the area of the proposed construction of Alignment and Installation of 1000mm Dia Gravity Sewer Line.
