Landslide Investigation In Turkey Using 2D Electrical Resistivity

CASE HISTORY

Objective: To delineate the landslide's body and slip plane depth and take measurements before repairing the damage and reconstructing the highway.

Survey site: Cankiri, Northern Turkey

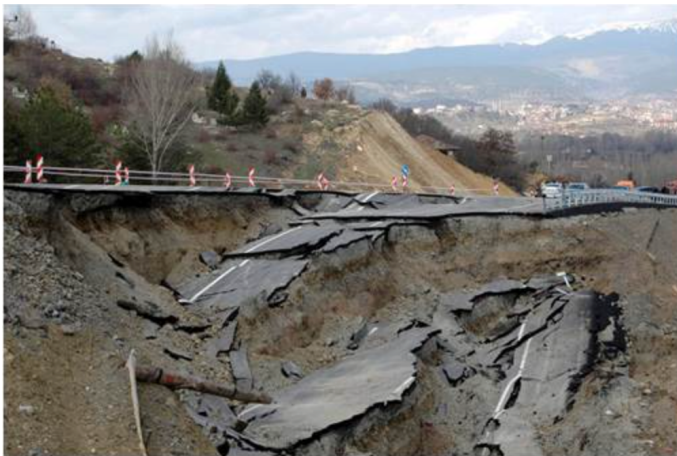
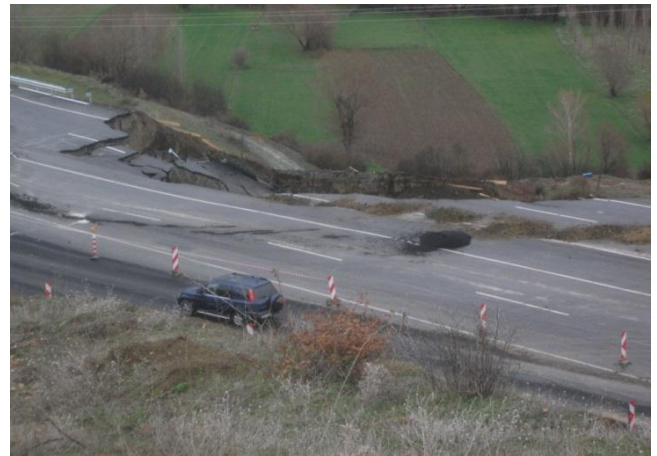
In 2011, after a record-setting month of rainfall, a landslide devastated the infrastructure and roads near Cankiri in Northern Turkey, effectively cutting the highway from two cities. Fortunately, the landslide occurred in the evening, and there were no casualties.

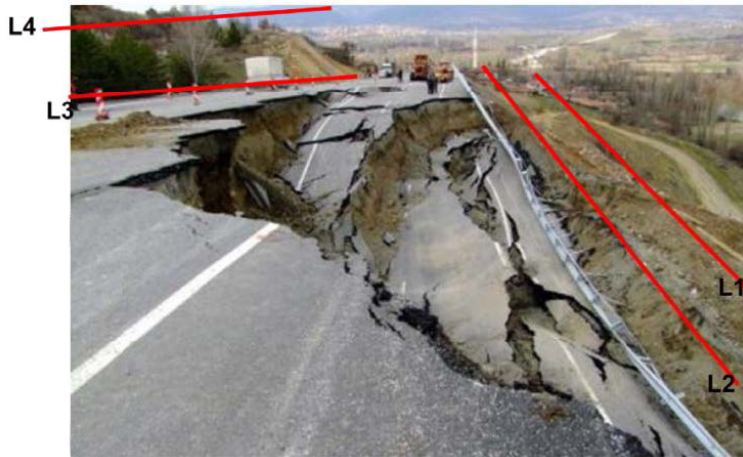
The client used our multi-channel resistivity instrument, the SuperSting™ R8. They used 56 electrodes spaced five meters apart along 275-meter-long lines. The sounding-profiling apparent resistivity data sets were obtained from extended Dipole-Dipole and Pole-Dipole arrays.

The depth of detection was approximately 60 meters. They also measured coordinates and elevation of each electrode to include surface topography in the 2D and 3D inversion, using EarthImager™ 2D and EarthImager™ 3D software in 2D and 3D inversion, respectively.

Because the topography of the area did not allow for direct 3D measurements, they used four different lines of data using EarthImager™ 2D. The 2D data interpretations were then combined to make 3D images.

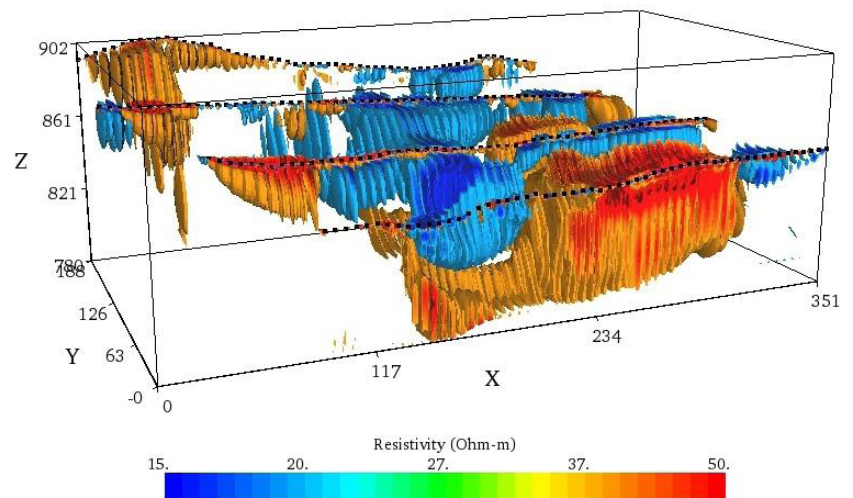
3D Resistivity Contour Plot

The 3D images showed the depth of the landslide body and other weak zones in the area (as noted above).

Based on that information, the client surmised that it was safe to rebuild the highway in the current site with several stipulations: Most notably, they suggested making drainage in the weak zones.
