The objective of the investigation was to assist in the evaluation of the integrity of a chimney soil-crete grouting foundation. Drilling to verify the integrity of the foundation suggested the possibility of the soil-crete columns being smaller than the design specifications with potential zones of ineffective grouting. There was also a possibility of voids created during grouting due to possible sand collapse. More grout was also injected than anticipated raising questions regarding the integrity of the soil-crete foundation in general.

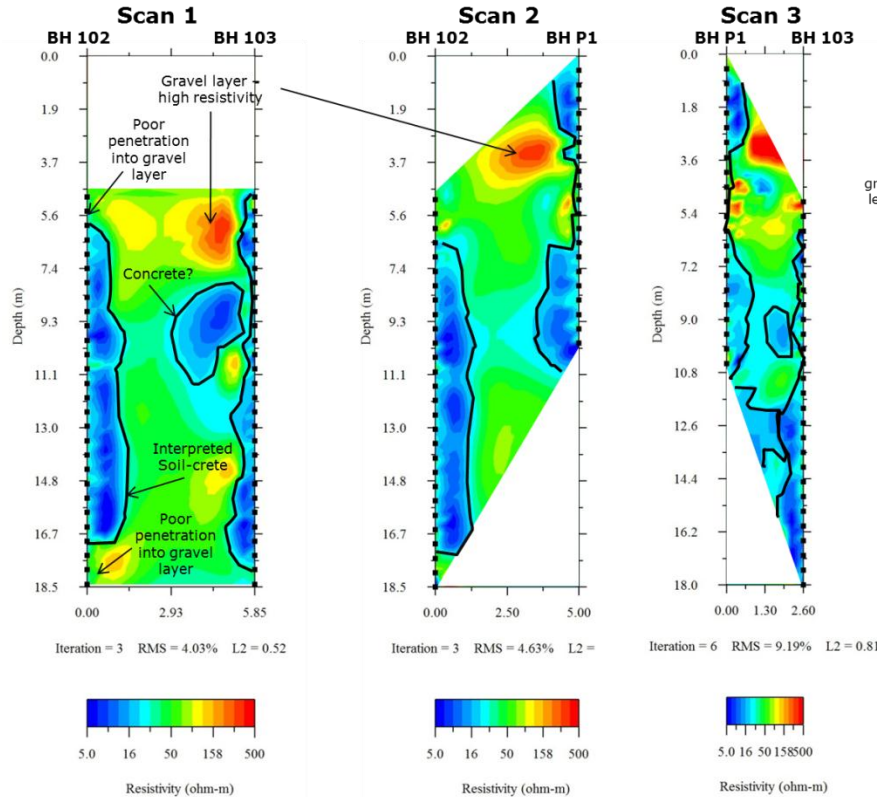
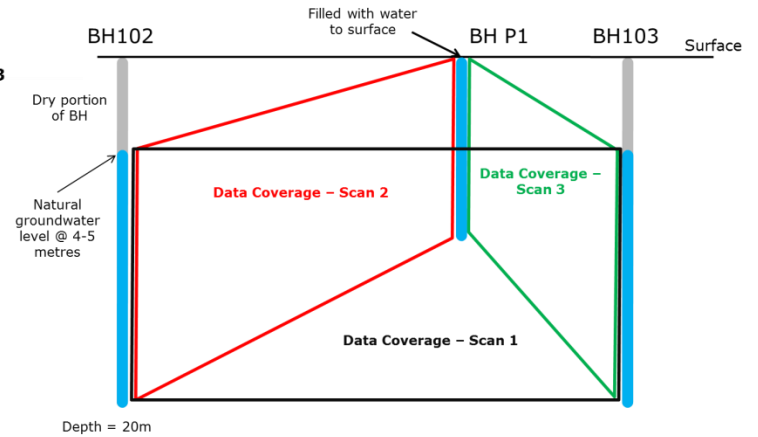
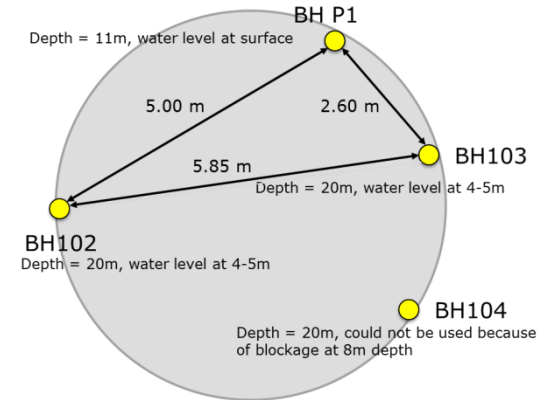
Resistivity data was acquired using an AGI SuperSting 8 channel automatic resistivity system using two 28 electrode cables with 0.5 m separation between electrodes.

The Bipole-Bipole and Dipole-Dipole array configurations were used to acquire the data.
