# 3D Resistivity Imaging of Geotechnical Properties at a Construction Site

**Results:** Electrical resistivity imaging successfully delineated the presence of expansive clays and clayey-sands and a shallow water table in a fine-grained soil environment in previously undocumented areas. Available upfront borings correlate well with ERI survey results.

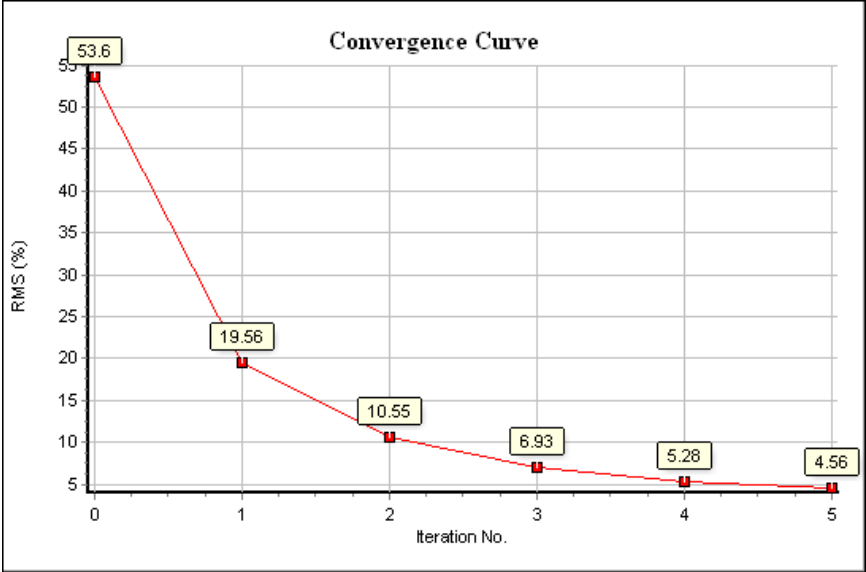
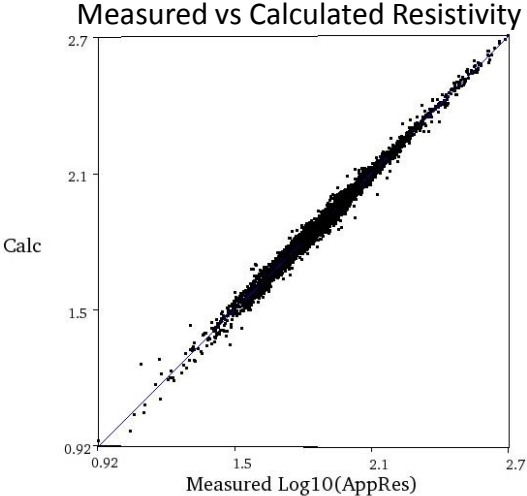
Iteration No. 5. RMS = 4.6%. L2 = 0.8

Full 3D Model of 83,912 m<sup>3</sup>  
 560 total electrodes installed  
 7,188 resistivity measurements  
 Finite Element Cells = 89,964

These plots show that the raw data are very clean and the resulting finite element model fits the raw data well

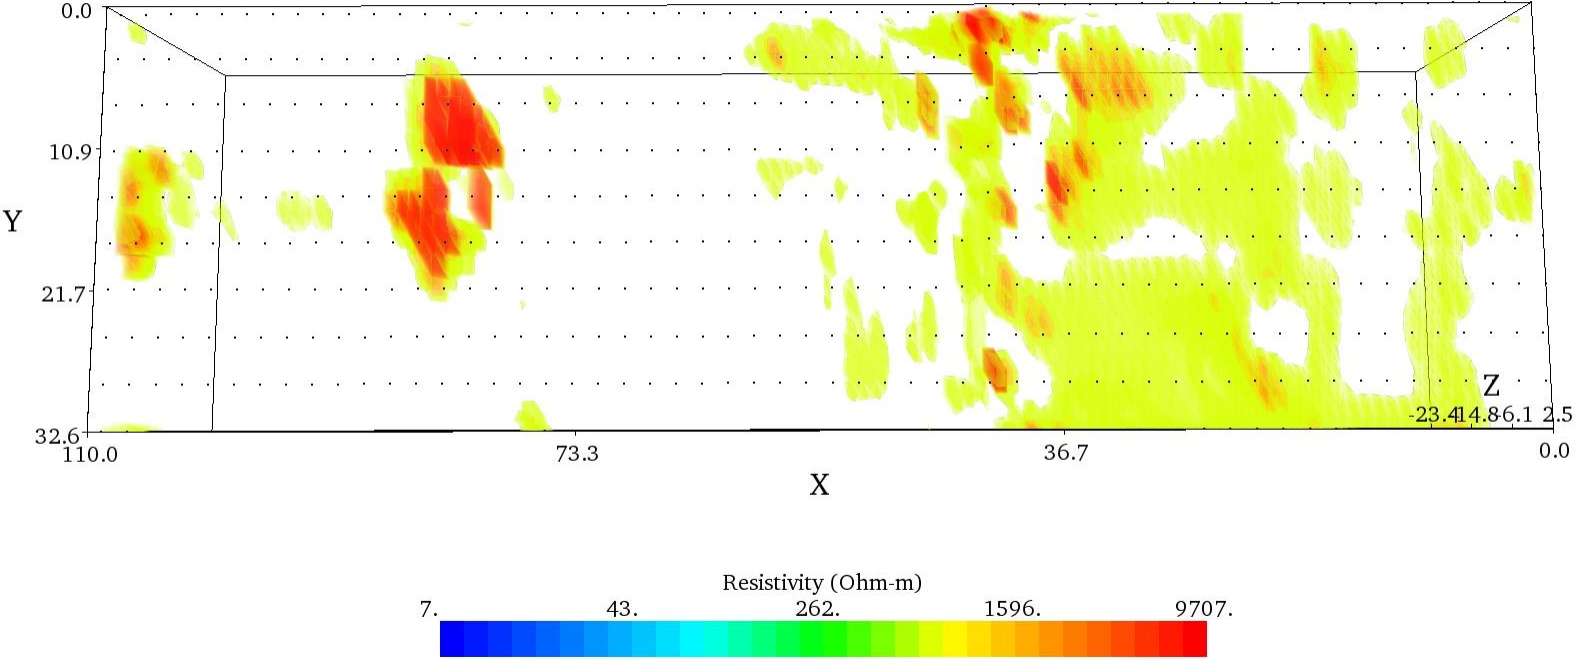
Resistivity values closely associated with Sandy Clay found in boreholes

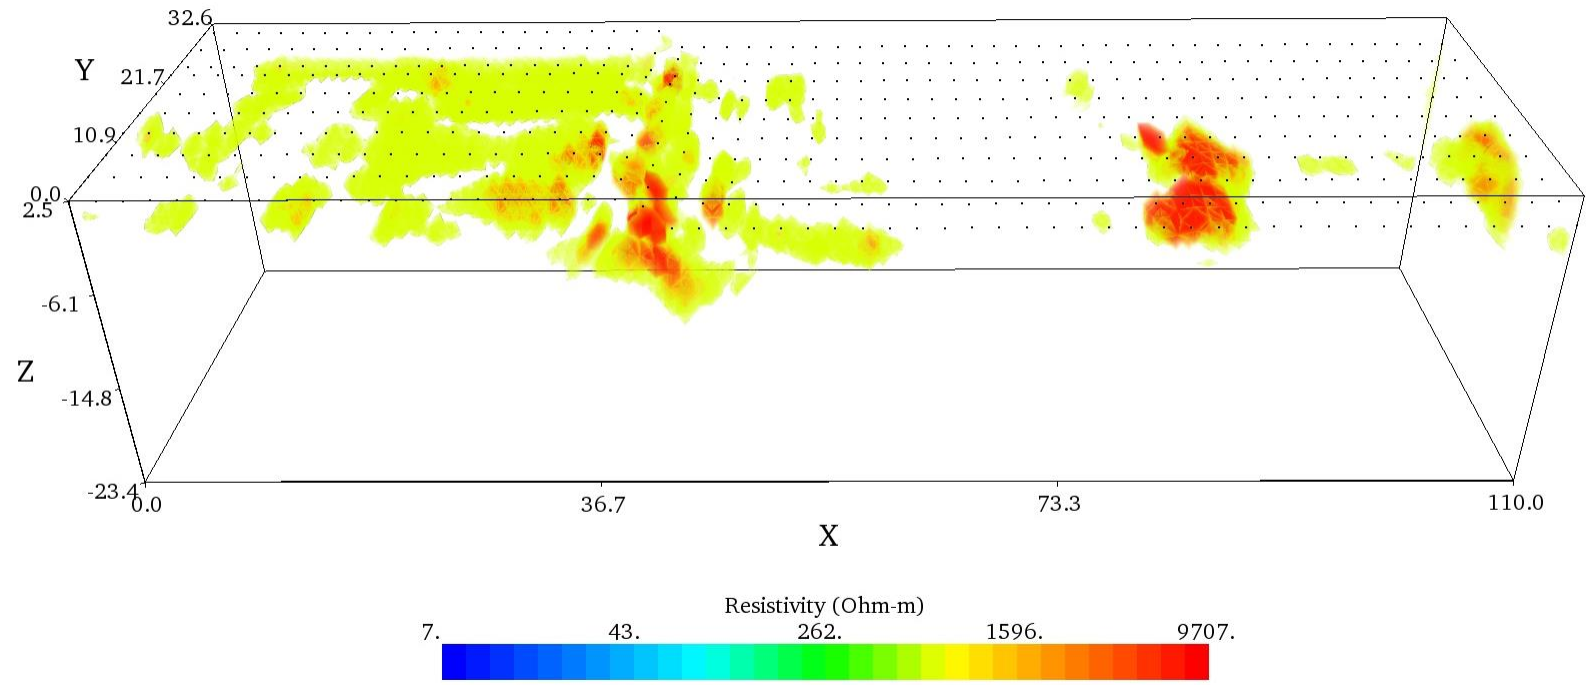
Resistivity values closely associated with Sandy Clay found in boreholes

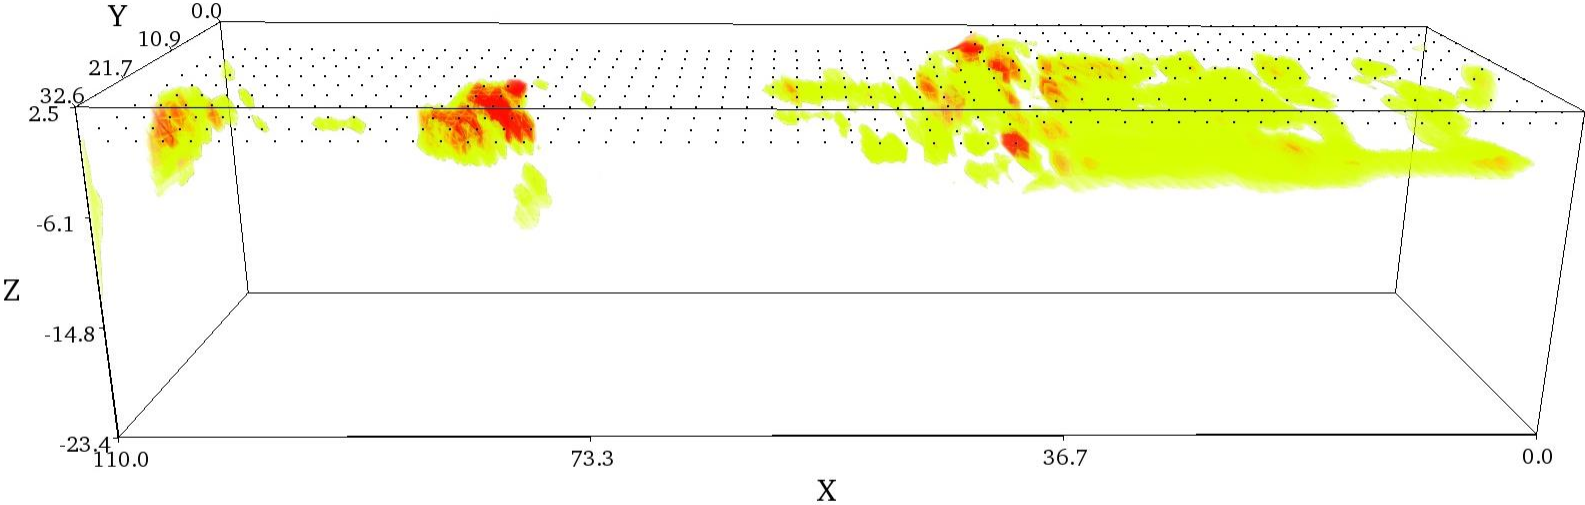
Resistivity values closely associated with Sandy Clay found in boreholes

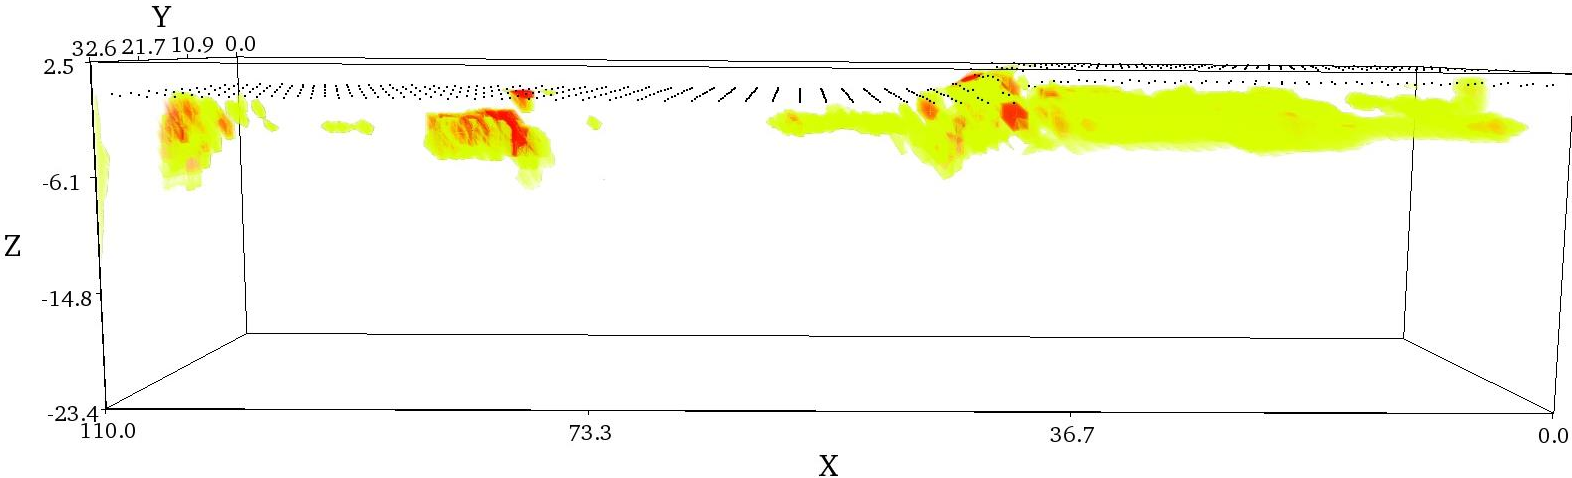
Resistivity values closely associated with Sandy Clay found in boreholes

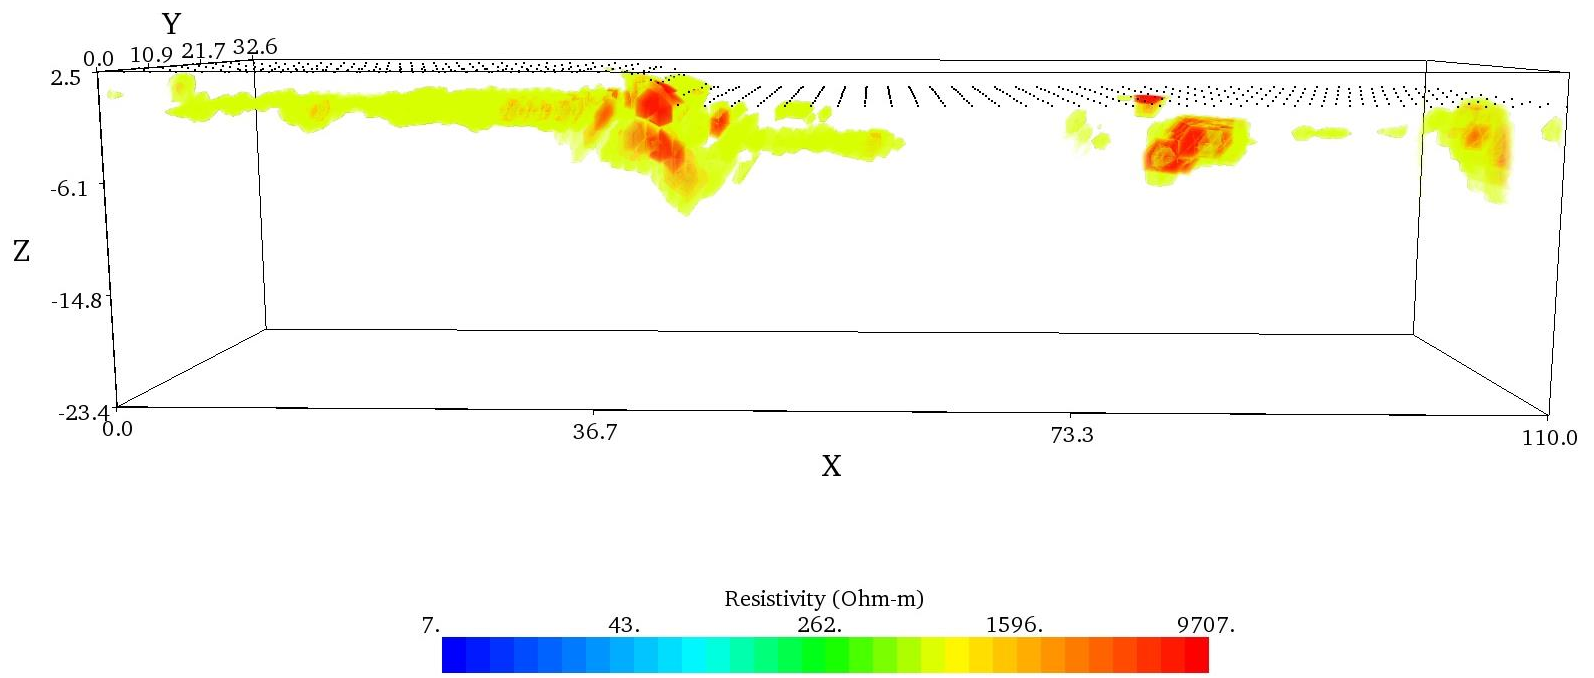
Resistivity values closely associated with Sandy Clay found in boreholes

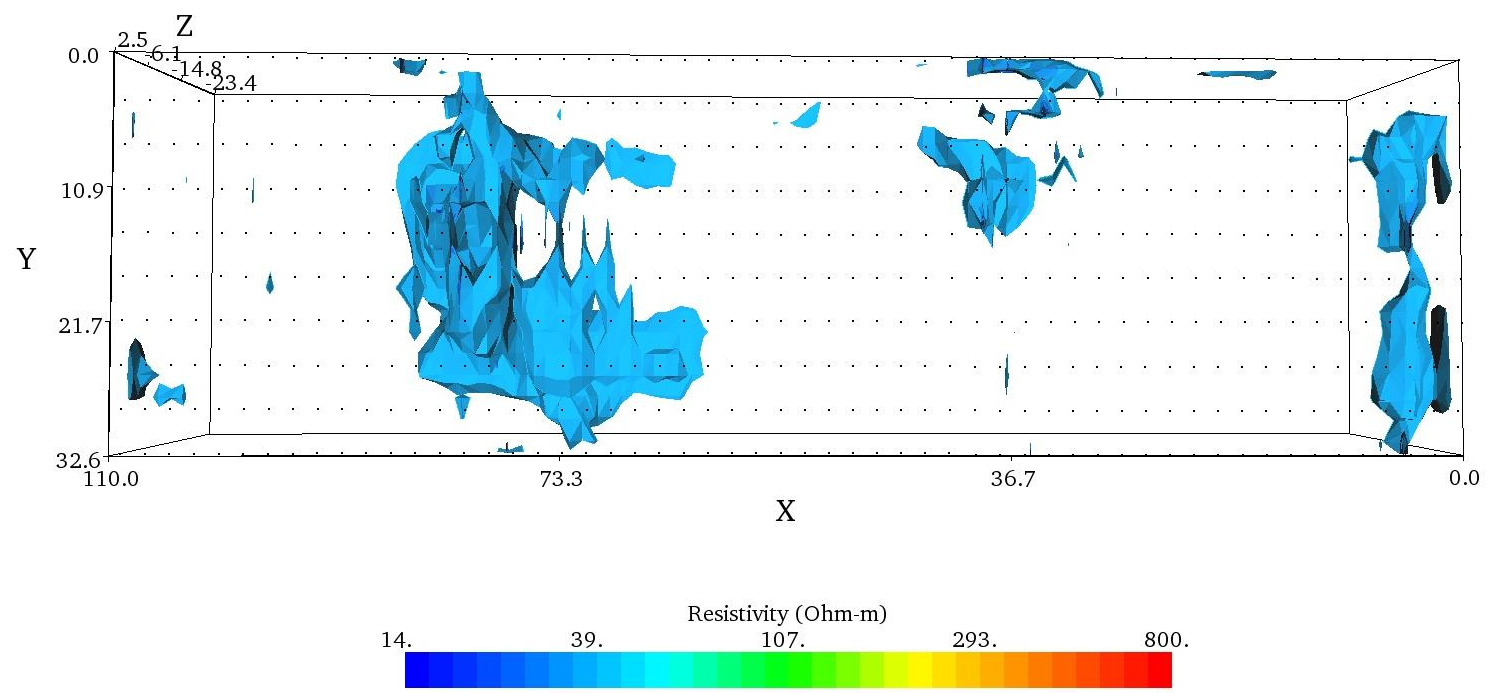
Resistivity values closely associated with Clays found in boreholes

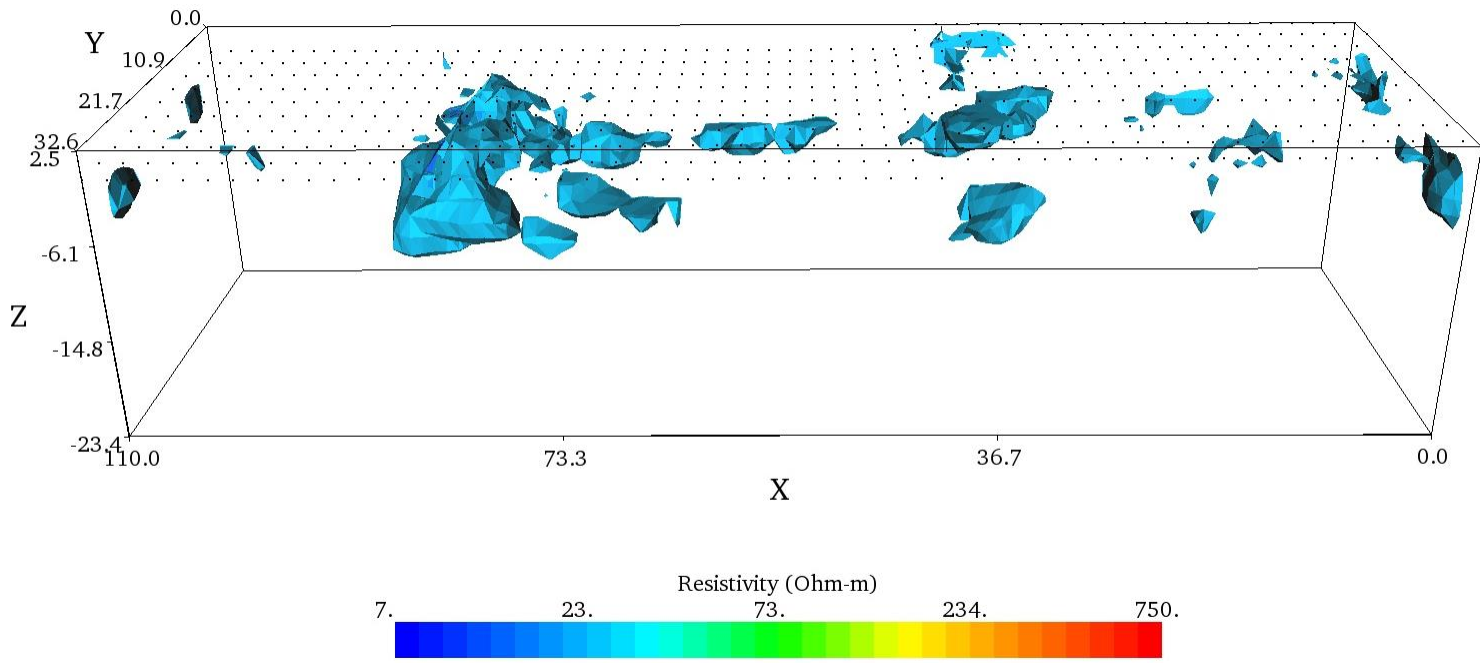
Resistivity values closely associated with Clays found in boreholes

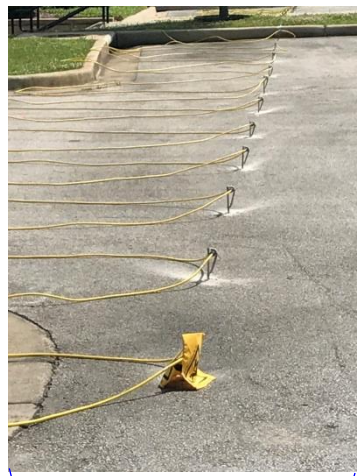
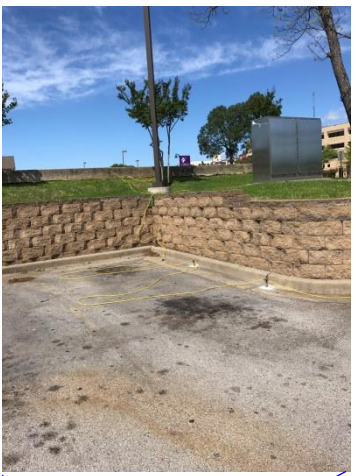
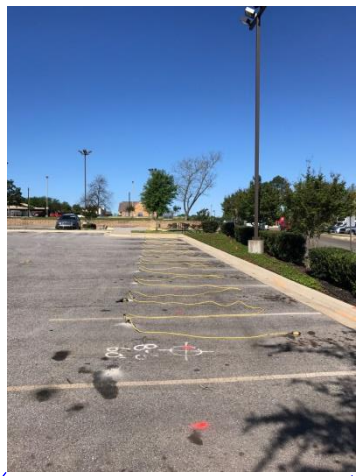
Drilling of asphalt/concrete for electrode stake installation

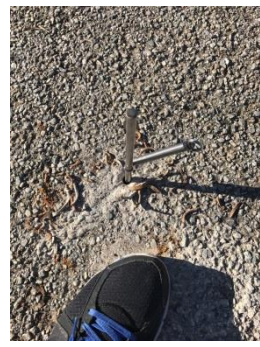
Installing electrode stake in asphalt/concrete for ERI survey
