WATER DAM LEAKAGE INSPECTION

ERT geophysical inspection to find potential seepage areas in an earthen dam

CASE HISTORY

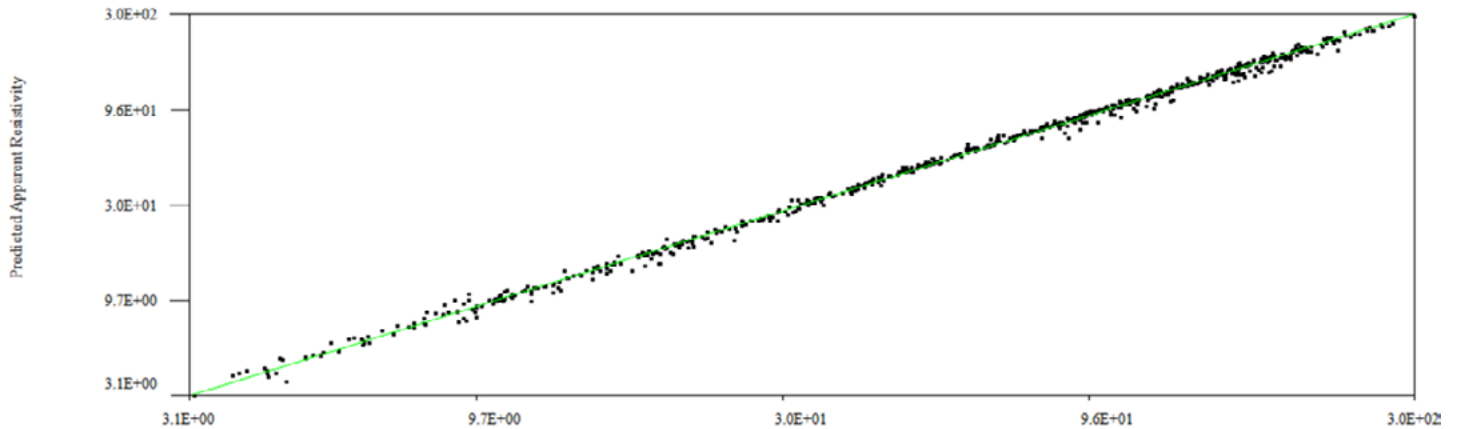
Crossplot of Measured vs Predicted Apparent Res. Data

The crossplot above shows that the data was obtained cleanly with very little noise.
